## INSTALLATION TIPS

# SUPER SHROUD 36 HP STYLE DOGHOUSE

### Fan Shroud Fitment Tips

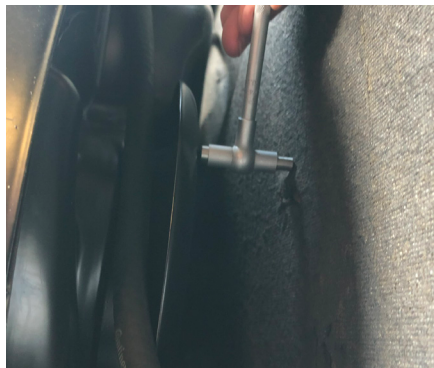
For the best performance we suggest at least 2" of clearance between the fan shroud inlet and the firewall. The more clearance you can achieve in this area the better. We found it necessary to trim the original firewall insulation in one of our test cars since it had bulged toward the fan shroud as it aged.
